NAVAL SUPPLY SYSTEMS COMMAND

***FISC Puget Sound
Manchester Fuel Department***

**Maintenance,
Leak Detection in Large
Underground Storage
Tanks**

Glenn E. Schmitt, P.E.
Environmental Director
Fleet and Industrial Supply Center
Puget Sound

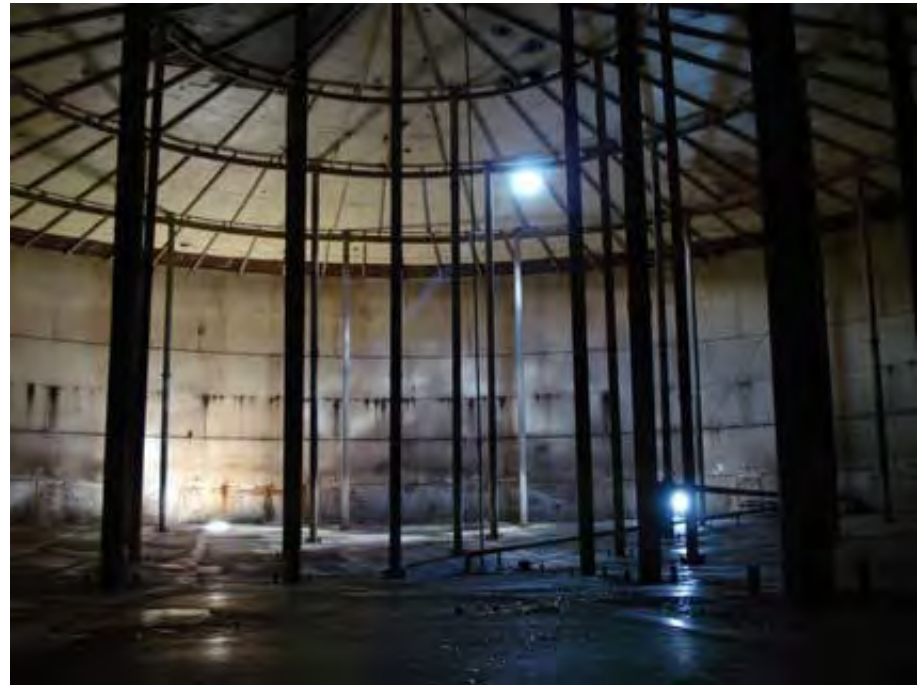
◆ April 26, 2007 FISC
Pearl Harbor
Reports a loss of
366,000 gallons
from tank 1403
(AST) (later
revised to 359,000
gallons)

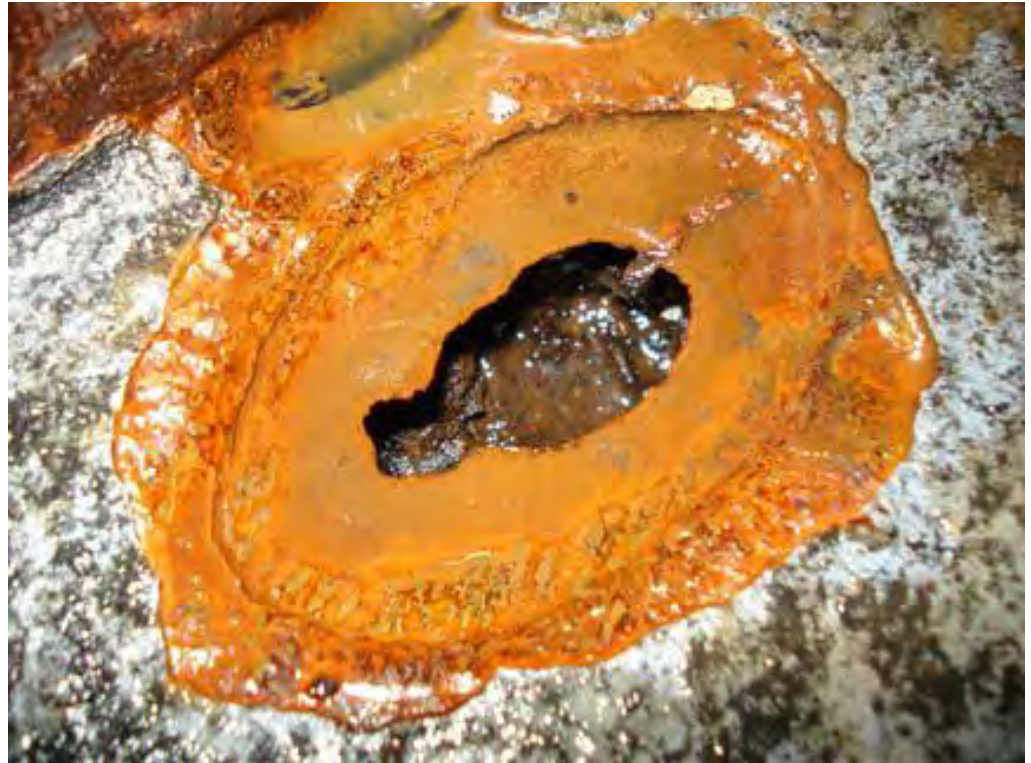
- ◆ Results – a 1 inch by 3 inch hole in sump
- ◆ Operator Error detecting loss

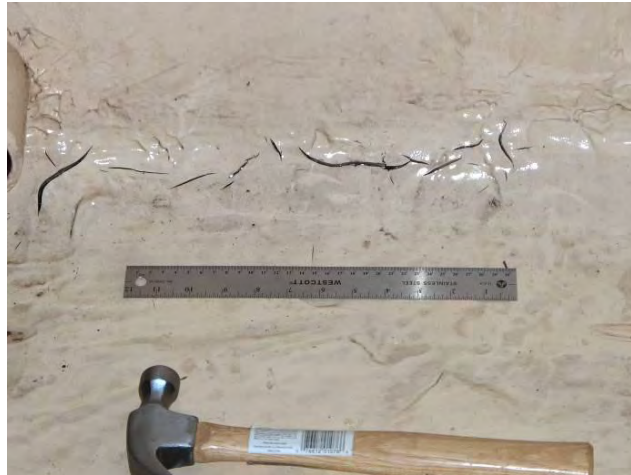
◆ Failure at the Tank wall joint (cove Failure

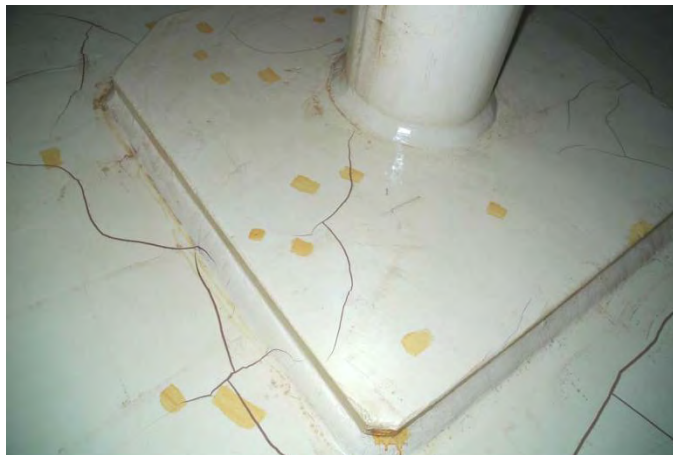
◆ Failure of floor coating

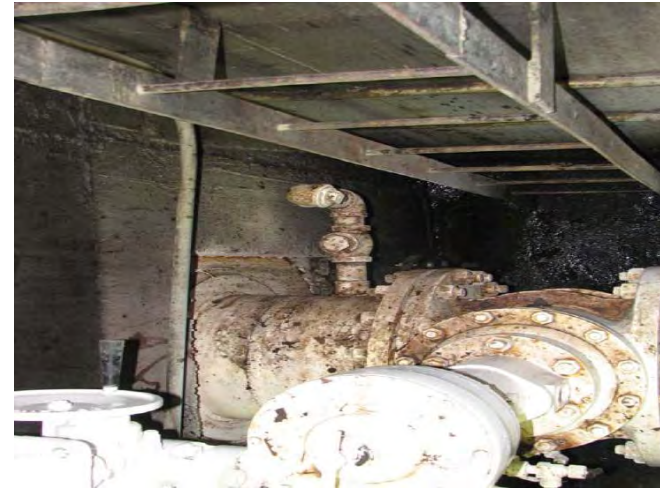
◆ Leaking Skin
Valves/Pipe nipples

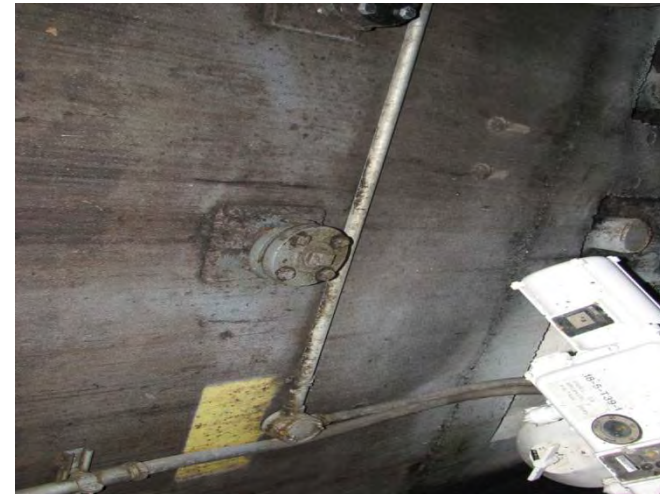
◆ Leaking older
Tank Penetrations
